# PRODUCT **RECALLS**

THE SGS PUBLICATION GATHERING CONSUMER PRODUCT RECALLS  
IN THE EU, IN THE USA AND IN AUSTRALIA

16 – 31 AUGUST 2010

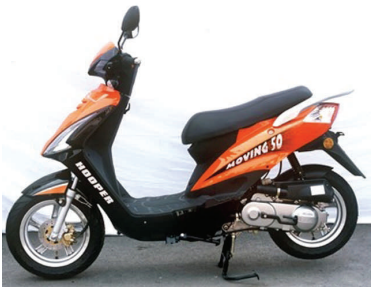
| AUTO: MOTOR VEHICLE | | | |
|---|---|---|---|
| EU/France | <p><b>CATEGORY:</b> Motor vehicles</p> <p><b>PRODUCT:</b> Motor scooter - Moving 50cc</p> <p><b>BRAND:</b> Qingqi / Hooper</p> <p><b>TYPE/NUMBER OF MODEL:</b> Type QM50QT2EC Type approval No e4*2002/24*1358*00. Models manufactured in 2009 until June 2010. Chassis numbers starting with: LAEA BZ4009B99 (followed by 4 characters).</p> <p><b>DESCRIPTION:</b> Four-stroke petrol-engine scooter with 12-inch alloy wheels.</p> <p><b>COUNTRY OF ORIGIN:</b> China</p> | <p><b>INJURIES</b></p> <p>The product poses a risk of injuries because there is a possibility that the chassis can break at the level of the horizontal and longitudinal spars at the centre of the scooter, due to a structural weakness, with a consequent risk of an accident.</p> <p>Ten cases of breakage have been reported, including one serious case involving a fatality.</p> | Voluntary recall from consumers by the importer. |
