# PRODUCT **RECALLS**

THE SGS PUBLICATION GATHERING CONSUMER PRODUCT RECALLS  
IN THE EU, IN THE USA AND IN AUSTRALIA

16 – 31 JULY 2010

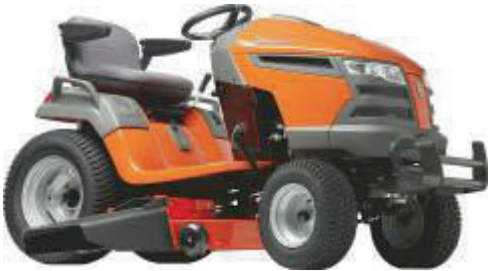
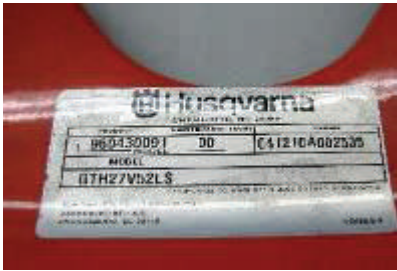
<p><b>HAZARD</b></p> <p>The fuel line on the rear-mounted fuel tank is too long and can come in contact with moving parts while the tractor is in use, posing a fire hazard.</p> <p><b>INCIDENTS/INJURIES</b></p> <p>The firm has received 53 reports of fuel line damage. No injuries have been reported.</p>	<p>Voluntary recall</p>
