PRODUCT **RECALLS**

THE SGS PUBLICATION GATHERING CONSUMER PRODUCT RECALLS
IN THE EU, IN THE USA AND IN AUSTRALIA

01 – 15 MARCH 2011

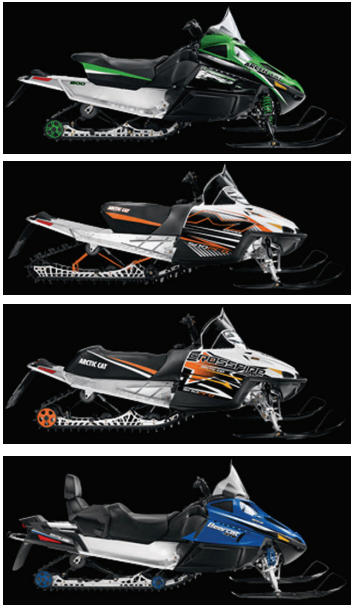
AUTO: MOTOR VEHICLE			
NOTIFYING COUNTRY	PRODUCT	DANGER	MEASURES ADOPTED
EU/SWEDEN	<p>CATEGORY: Motor vehicles</p> <p>PRODUCT: Snowmobiles</p> <p>BRAND: Arctic Cat</p> <p>TYPE/NUMBER OF MODEL: Arctic Cat model Z1, TZ1, F, Bearcat, M and CF. Model year 2010</p> <p>DESCRIPTION: Arctic Cat snowmobiles in variations of colour and model features. The model name is indicated on the side of vehicle, in the registration materials and owner's manual.</p> <p>COUNTRY OF ORIGIN: United States</p>

<p>INJURIES</p> <p>The product poses a risk of injuries because the front lower suspension arm can crack during use which could lead to loss of control.</p>	Voluntary corrective action.
EU/GREECE	<p>CATEGORY: Motor vehicles</p> <p>PRODUCT: Passenger car Corsa D</p> <p>BRAND: Opel</p> <p>TYPE/NUMBER OF MODEL: The recall concerns 2011 and 2012 model year Corsa D vehicles, with VINs from B 4 185570 to C 4 000027.</p> <p>DESCRIPTION: Passenger car</p> <p>COUNTRY OF ORIGIN: Spain</p> <p>No picture available</p>	<p>INJURIES</p> <p>The passenger airbag cover may become loose or detached from the instrument panel if the airbag is deployed.</p>	Voluntary corrective action taken by the manufacturer.

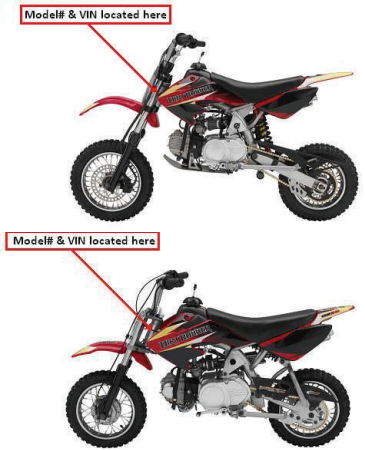
AUTO: MOTOR VEHICLE			
NOTIFYING COUNTRY	PRODUCT	DAANGER	MEASURES ADOPTED
USA	<p>NAME OF PRODUCT: Dirt Bikes</p> <p>UNITS: About 4,300</p> <p>IMPORTER: Baja Inc., d/b/a Baja Motorsports, of Anderson, S.C.</p> <p>DESCRIPTION: This recall involves all model DR50 and DR70 Baja dirt bikes with VIN numbers beginning with "L98." The model number and VIN are located on the product data plate, which is located on the side of the "goose neck" (where the handle bars meet the body of the bike).</p> <p>MANUFACTURED in: China</p> <p>Model# & VIN located here</p>

<p>Model# & VIN located here</p>	<p>HAZARD</p> <p>Fuel can leak from the fuel tank, posing a fire and burn hazard to consumers.</p> <p>INCIDENTS/INJURIES</p> <p>The firm has received six reports of fires from fuel leakage including one report of minor burns to a consumer's legs.</p>	Voluntary recall
USA	<p>VEHICLE MAKE / MODEL</p> <p>TOYOTA / FJ CRUISER- 2008-2011 TOYOTA / LAND CRUISER- 2008-2011 TOYOTA / SEQUOIA- 2008-2011 TOYOTA / TACOMA- 2008-2011 TOYOTA / TUNDRA- 2008-2011</p> <p>MANUFACTURER: TOYOTA MOTOR NORTH AMERICA, INC.</p> <p>COMPONENT: TIRES:PRESSURE MONITORING AND REGULATING SYSTEMS</p> <p>POTENTIAL NUMBER OF UNITS AFFECTED: 22,000</p> <p>SUMMARY: TOYOTA is recalling certain model year 2008 through 2011 fj cruiser, land cruiser, tacoma, sequoia and tundra vehicles for failing to comply with the requirements of federal motor vehicle safety standard no. 138, "tire pressure monitoring system (tpms)." the tire pressure monitoring systems were not re-calibrated correctly and therefore do not start illuminating the low tire pressure warning telltale at the required minimum activation pressure</p> <p>No picture available.</p>	<p>CONSEQUENCE</p> <p>Failure to warn of tire deflations is a non-compliance with fmvss 138 and could lead to tire failure increasing the risk of a crash.</p>	<p>REMEDY</p> <p>Dealers will re-initialize the tire pressure monitoring system free of charge. The manufacturer has not yet provided an owner notification schedule. Owners may contact Toyota at 1-800-331-4331.</p>
