# PRODUCT **RECALLS**

THE SGS PUBLICATION GATHERING CONSUMER PRODUCT RECALLS  
IN THE EU, IN THE USA AND IN AUSTRALIA

01 – 15 OCTOBER 2010

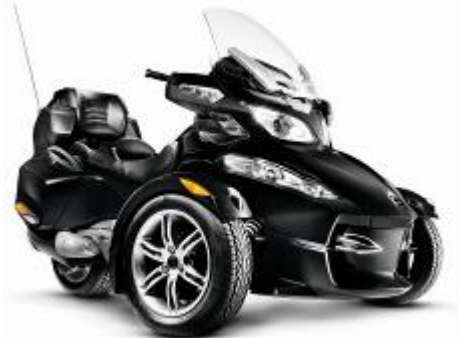
| AUTO: MOTOR VEHICLE | | | |
|---|---|--|---|
| <b>AUSTRALIA</b> | <p>BRP Australia Pty Ltd—Can-Am Spyder Roadster (this replaces recall PRA 2009/10953)</p> <p><b>PRODUCT DESCRIPTION</b></p> <p>Can-Am Spyder Roadster RS, RT and GS.</p> <p><b>IDENTIFYING FEATURES</b></p> <p>All models except those listed in the excluded vehicles list (see supporting documentation)<br/>Target Number: 547</p> <p><b>TRADERS WHO SOLD THIS PRODUCT</b></p> <p>BRP Australia Can-Am Spyder Dealers, in all states of Australia, New Zealand, Pacific Islands and through distributors in Asia.</p> <p><b>SUPPLIER</b></p> <p>BRP Australia Pty Ltd</p> <p><b>SUPPLIER'S WEB SITE</b></p> <p><a href="http://www.brp.com">http://www.brp.com</a></p> | <p><b>HAZARDS</b></p> <p>If the defect occurs the vehicle may steer out of lane, which increases the possibility of a crash with other traffic or of the vehicle leaving the road.</p> <p><b>DEFECTS</b></p> <p>A situation may occur where the rider may need to exert a force greater than expected to turn the handlebar in order to correct the vehicle's trajectory. At this increased level of force the handlebar may be turned more than the rider had intended.</p> | <p><b>CONSUMERS ACTION</b></p> <p>Contact a BRP Spyder dealer as soon as possible to arrange to have the vehicle repaired, free of cost.</p> |
