PRODUCT **RECALLS**

THE SGS PUBLICATION GATHERING CONSUMER PRODUCT RECALLS
IN THE EU, IN THE USA AND IN AUSTRALIA

01 – 15 SEPTEMBER 2010

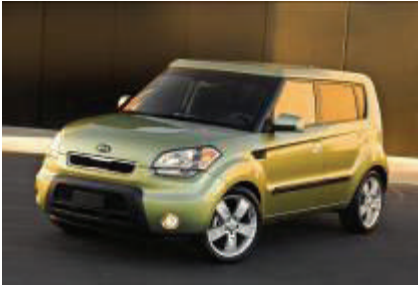
NOTIFYING COUNTRY	PRODUCT	DANGER	MEASURES ADOPTED
<p>AUSTRALIA</p>	<p>Kia—Soul</p> <p>PRODUCT DESCRIPTION Kia Soul Vehicles produced between 7 September 2009 and 8 June 2010</p> <p>IDENTIFYING FEATURES Campaign Number: 101060R0 Target Number: 27</p> <p>SUPPLIER Kia Motors Australia</p>

<p>HAZARDS The wiring may become heat affected.</p> <p>DEFECTS There is an issue with the wiring that controls the illumination of the speaker.</p>	<p>CONSUMERS ACTION Arrange an appointment with your nearest Kia service dealer to arrange inspection and replacement of the illumination wiring.</p>
<p>AUSTRALIA</p>	<p>Kia—Sorento</p> <p>PRODUCT DESCRIPTION Kia Sorento vehicles produced between September 2009 to June 2010</p> <p>IDENTIFYING FEATURES Campaign Number: 101060R3 Target Number: 1,029 Affected Vehicle VIN Range: KNAKU813MA5050763 to KNAKU813MA5050767 KNAKU814SA5026243 to KNAKU814SA5108829</p> <p>SUPPLIER Kia Motors Australia</p>

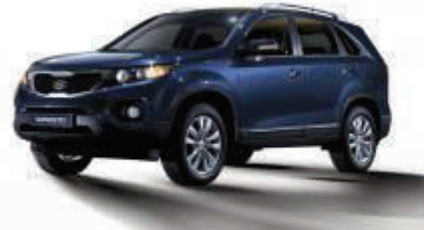
<p>HAZARDS The wiring may short and cause heat damage.</p> <p>DEFECTS There is a design flaw with the wiring to the door trim illumination.</p>	<p>CONSUMERS ACTION Arrange an appointment with your nearest Kia service dealer to arrange inspection and replacement of the wiring loom for the door trim illumination on all four doors.</p>

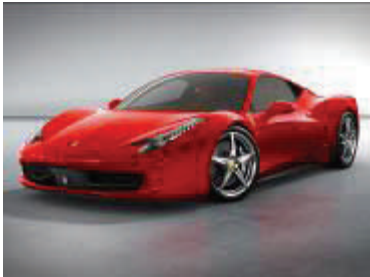
AUTO: MOTOR VEHICLE			
NOTIFYING COUNTRY	PRODUCT	DA NGER	MEASURES ADOPTED
AUSTRALIA	<p>Ateco Automotive Pty Ltd—Ferrari 458</p> <p>PRODUCT DESCRIPTION</p> <p>Ferrari 458</p> <p>Identifying features</p> <p>Target Number: 22</p> <p>Campaign: 51</p> <p>SUPPLIER</p> <p>Ateco Automotive Pty Ltd</p>

<p>HAZARDS</p> <p>The adhesive used in the assembly may overheat and produce smoke; or it may ignite in particularly high ambient and operating temperature conditions.</p> <p>DEFECTS</p> <p>There is a possible non-conformity in the assembly of the wheelhouse and its repective heat shield.</p>	<p>CONSUMERS ACTION</p> <p>Ferrari have contacted all owners.</p>
AUSTRALIA	<p>Mazda—BT-50 Automatic Transmission Shift Cable Bracket</p> <p>PRODUCT DESCRIPTION</p> <p>Mazda BT-50 with Automatic Transmission</p> <p>IDENTIFYING FEATURES</p> <p>VIN Range:</p> <p>MM0 UNY0E3 00641775—MM0 UNY0E3 00694613 (Pre-facelift Model)</p> <p>MM0 UNY0E4 00804848—MM0 UNY0E4 00812666 (Facelift Model)</p> <p>Target Number: 1, 150</p> <p>Campaign Number: R201002</p> <p>SUPPLIER</p> <p>Mazda Australia Pty Limited</p> <p>No picture available.</p>	<p>HAZARDS</p> <p>Should the defect occur, high shift efforts or no shift for selected gears may result.</p> <p>DEFECTS</p> <p>There is a possibility that the Automatic Transmission Shift Cable Bracket fitted to the affected vehicles may have unnecessary welding and may not meet specification. This weld could lead to cracking/breakage of the bracket.</p>	<p>CONSUMERS ACTION</p> <p>Owners of affected vehicles will be contacted by mail and requested to present their vehicle to a Mazda Dealer for repair. Consumers may obtain further information by contacting any Mazda dealer or free-call 1800 034 411 (10:00am to 4:00pm, Eastern Standard Time, Monday—Friday) to speak to Mazda Customer Service Representatives.</p>
