PRODUCT **RECALLS**

THE SGS PUBLICATION GATHERING CONSUMER PRODUCT RECALLS
IN THE EU, IN THE USA AND IN AUSTRALIA

16 – 30 SEPTEMBER 2011

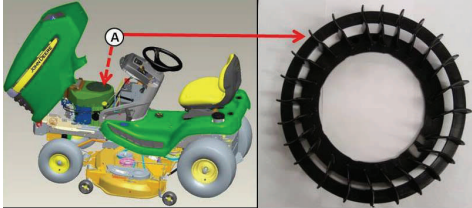
<p>HAZARD</p> <p>The cooling fan (A) installed on top of the front mounted Kawasaki engine in the lawn tractor can break. If the cooling fan is not operational, the engine can overheat causing the surrounding plastic to melt, creating the risk of fire and serious injury.</p> <p>INCIDENTS/INJURIES</p> <p>There have been 163 reported failures, including 83 reports of engine melting or engine fires and one report of a minor burn injury following a fan failure fire.</p>	Voluntary recall.
