PRODUCT **RECALLS**

THE SGS PUBLICATION GATHERING CONSUMER PRODUCT RECALLS
IN THE EU, IN THE USA AND IN AUSTRALIA

16 – 30 SEPTEMBER 2010

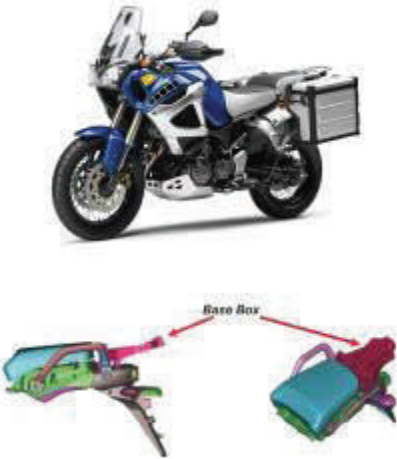
| AUTO: MOTOR VEHICLE | | | |
|---|---|---|---|
| AUSTRALIA | <p>Yamaha—XT1200Z Base Box</p> <p>PRODUCT DESCRIPTION</p> <p>Yamaha XT1200Z</p> <p>IDENTIFYING FEATURES</p> <p>Campaign Number: BB/XT1200 Target Number: TBA VIN Range: XT1200ZDP014000002 to XT1200ZDP014000354</p> <p>SUPPLIER</p> <p>Yamaha Motor Australia Pty Ltd</p> | <p>HAZARDS</p> <p>The top case may become completely detached from the motorcycle.</p> <p>DEFECTS</p> <p>When the motorcycle is ridden with either the Genuine Yamaha Accessory Aluminium Top Case (23P-W0754-00) or a similar aftermarket product, the Base box may develop a crack and eventually break.</p> | <p>CONSUMERS ACTION</p> <p>Yamaha will write to all affected owners.</p> <p>Owners are advised to cease using any type of Top Case until further notice from Yamaha Motor Australia. When the revised base box is available Yamaha will contact owners to advise how to have the new part fitted free of cost.</p> <p>If you no longer own the unit, please advise Yamaha motor Australia on 1300 593 600</p> |

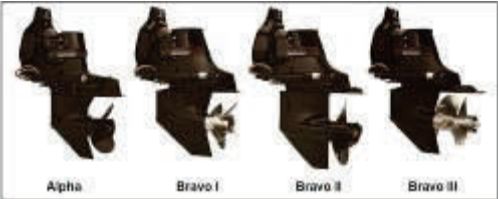
| NOTIFYING COUNTRY | PRODUCT | DANGER | MEASURES ADOPTED |
|---|---|---|---|
| <p>AUSTRALIA</p> | <p>Marine Power International Pty Ltd—Mercury MerCruiser Stern Drive Packages (power boat engines)</p> <p>PRODUCT DESCRIPTION</p> <p>MerCruiser 4-cylinder, V-6, V-8 petrol and 4-cylinder, 6-cylinder diesel engine Stern Drive models supplied with Alpha & Bravo Transom Assemblies</p> <p>IDENTIFYING FEATURES</p> <p>ALPHA ENGINE Engine Serial Number Range: 1A602571 - 1A621587 Transom Serial Number Range: 1A194127 - 1A68107</p> <p>BRAVO ENGINE Engine Serial Number Range: 1A350418 - 1A621253 Transom Serial Number Range: 1A437945 - 1A444913</p> <p>LOOSE TRANSOMS (Spare Parts) Transom Serial Number Range: ALPHA 1A194127 - 1A468107 BRAVO 1A437945 - 1A444913 MC1 0A845988 - 0A846138</p> <p>SUPPLIER</p> <p>Marine Power International Pty Ltd</p> <p>SUPPLIER'S WEB SITE</p> <p>http://mercurymarine.com.au</p> | <p>HAZARDS</p> <p>Loss of gear control (forward, neutral, reverse)</p> <p>DEFECTS</p> <p>The core fitting of the intermediate gearshift cable of the engine may become detached from the core wire.</p> | <p>CONSUMERS ACTION</p> <p>Stop using boat and contact MerCruiser dealer to arrange for boat to be inspected and, if necessary, rectified.</p> |
