PRODUCT **RECALLS**

THE SGS PUBLICATION GATHERING CONSUMER PRODUCT RECALLS
IN THE EU, IN THE USA AND IN AUSTRALIA

01 – 15 APRIL 2012

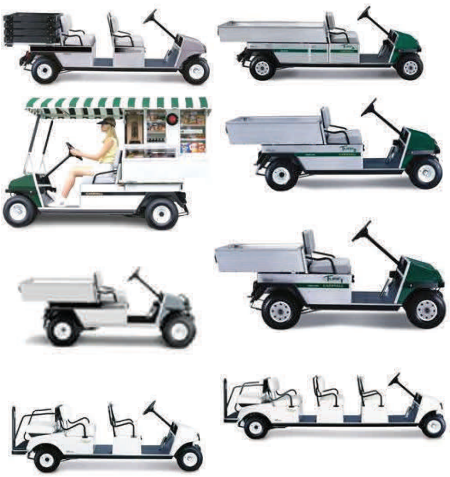
USA	<p>NAME OF PRODUCT: Utility and transport vehicles</p> <p>UNITS: About 100</p> <p>MANUFACTURER: Club Car, LLC of Augusta, Ga.</p> <p>DESCRIPTION: The recalled vehicles are various sizes, models and colors of model year 2012 gas and electric powered utility and transport vehicles used for short-distance transportation. The vehicles can be identified by model and serial number. The serial number is above and to the right of the accelerator pedal. A list of recalled models and serial numbers is below.</p> <p>MANUFACTURED IN: United States</p>	<p>HAZARD: The brake pedal mounting blocks can crack and separate, resulting in a loss of braking ability, resulting in a crash.</p> <p>INCIDENTS/INJURIES: Club Car has not received any reports of the brake pedal mounting blocks breaking. No injuries have been reported.</p>	Voluntary recall.
