PRODUCT **RECALLS**

THE SGS PUBLICATION GATHERING CONSUMER PRODUCT RECALLS
IN THE EU, IN THE USA AND IN AUSTRALIA

01 – 15 MARCH 2012

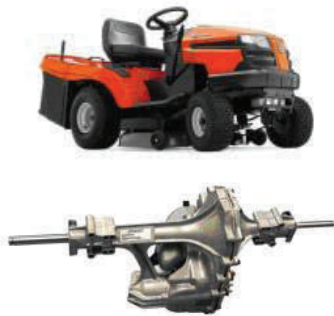
AUSTRALIA	<p>Husqvarna Pty Ltd— Lawn Tractor Models CTH2038 and CTH2642TE</p> <p>PRODUCT DESCRIPTION</p> <p>The affected Hydro-Gear transaxles were included in 54 lawn tractors manufactured by the Husqvarna Group from 1 December 2010 to 1 April 2011 under the brand name Husqvarna.</p> <p>IDENTIFYING FEATURES</p> <p>Hydro-Gear transaxle model no. 170061 with serial numbers 0333 through 0351 Husqvarna tractor model nos. CTH2038 and CTH2642TE with serial nos. 010611D001376 through 02150211D001032</p> <p>TRADERS WHO SOLD THIS PRODUCT</p> <p>Husqvarna dealers in Australia</p> <p>SUPPLIER</p> <p>Hydro-Gear Limited Partnership / Hydro-Gear Europe BVBA</p> <p>SUPPLIER'S WEB SITE</p> <p>http:// www.hydro-gear.com</p> <div style="text-align: center;">

</div>	<p>HAZARDS</p> <p>The drive gears may fail, causing the drive system to lose the ability to brake effectively, posing a risk of injury to the operator or bystanders.</p> <p>DEFECTS</p> <p>There is a potential defect in the bull gear, which will manifest itself as broken gear teeth under load and cause loss of engine braking.</p>	<p>Cease use of the lawn tractor immediately and contact the place of purchase to arrange for a service appointment and have the transaxle inspected to determine if a transaxle replacement is necessary. . For more information contact Husqvarna Technical Service on 1300 755 214 or at technical.service@husqvarna.com.au.</p>
