PRODUCT **RECALLS**

THE SGS PUBLICATION GATHERING CONSUMER PRODUCT RECALLS
IN THE EU, IN THE USA AND IN AUSTRALIA

01 – 15 MAY 2012

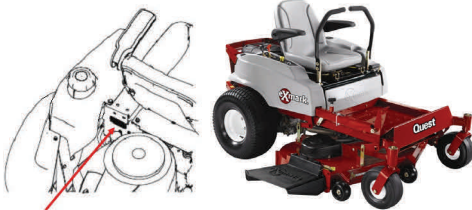
<p>HAZARD: Bearings supporting the riding mower's deck can fail and cause the deck to interfere with the operator's controls, resulting in a crash hazard.</p> <p>INCIDENTS/INJURIES: Exmark has received 18 reports of incidents. No injuries have been reported.</p>	<p>Voluntary recall.</p>
