# PRODUCT **RECALLS**

THE SGS PUBLICATION GATHERING CONSUMER PRODUCT RECALLS  
IN THE EU, IN THE USA AND IN AUSTRALIA

1-15 MAY 2013

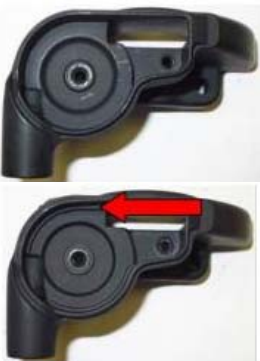
<p><b>DEFECTS</b></p> <p>Incorrectly produced inner cable retaining guide within the upper throttle housing.</p> <p><b>HAZARDS</b></p> <p>It may be possible for the inner cable to jump the cable wheel and be pinched between the cable wheel and the upper throttle housing. This may cause the throttle to stick and may pose a hazard to the rider and other road users.</p>	<p>A letter is being sent to affected owners. Follow Husqvarna/Paul Feeney Group instructions sent via Registered Mail, cease riding the motorcycle, return to an Authorised Husqvarna Dealer for replacement of the upper throttle housing.</p>

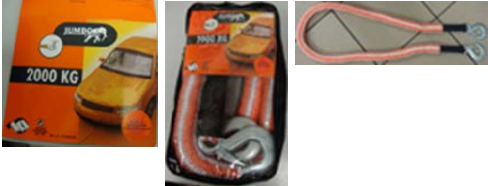
AUTO: MOTOR VEHICLE EQUIPMENT			
NOTIFYING COUNTRY	PRODUCT	DANGER	MEASURES ADOPTED
EU/POLAND	<p><b>CATEGORY:</b> Motor vehicles</p> <p><b>PRODUCT:</b> Tow rope</p> <p><b>BRAND:</b> JUMBO</p> <p><b>NAME:</b> Unknown</p> <p><b>TYPE/NUMBER OF MODEL:</b> art. no. 6154032T/model: Jumbo 2000kg</p> <p>Batch number/Barcode: 8711263561543</p> <p><b>DESCRIPTION:</b> Tow rope made of nylon weave in white and orange colour. Suitable for cars weighing up to 2 tonnes.</p> <p><b>COUNTRY OF ORIGIN:</b> The Netherlands</p>

<p><b>INJURIES</b></p> <p>The strength of the tow rope is insufficient for the declared weight of cars (2000 kg). As a result, the tow rope may break during use, causing a road traffic accident.</p>	<p>Voluntary measures:</p> <p>Withdrawal of the product from the market</p>
AUSTRALIA	<p>Monza Imports Australia—KBC VR-1X Motorcycle Helmet</p> <p><b>PRODUCT DESCRIPTION</b></p> <p>Motorcycle safety helmet</p> <p><b>IDENTIFYING FEATURES</b></p> <p>Manufacture date: 2012-6</p> <p>The manufacture date can be seen on the Vehicle User Helmet Warning label stitched inside the comfort liner.</p> <p><b>TRADERS WHO SOLD THIS PRODUCT</b></p> <p>Motorcycle dealers who stock KBC helmets</p> <p><b>SUPPLIER</b></p> <p>Monza Imports Australia P/L</p> <p><b>SUPPLIER'S WEB SITE</b></p> <p><a href="http://www.monzaimports.com.au/">http://www.monzaimports.com.au/</a></p> <p>No picture available.</p>	<p><b>DEFECTS</b></p> <p>Affected KBC VR-1X motorcycle helmets do not meet performance requirements that are outlined in the Australian/New Zealand Standard AS/NZS1698:2006.</p> <p><b>HAZARDS</b></p> <p>There is a possibility that the helmets may not provide adequate protection to the wearer in the event of an accident and may increase the risk of death or serious injury to the wearer.</p>	<p>Consumers should immediately stop using the helmets and return it to the place of purchase for a refund or replacement.</p>
