PRODUCT **RECALLS**

THE SGS PUBLICATION GATHERING CONSUMER PRODUCT RECALLS
IN THE EU, IN THE USA AND IN AUSTRALIA

16 – 30 JUNE 2013

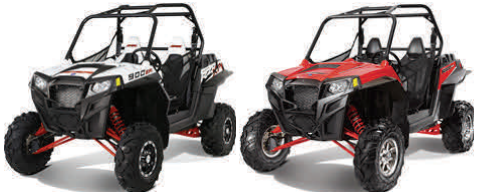
AUTO: MOTOR VEHICLE			
NOTIFYING COUNTRY	PRODUCT	DA NGER	MEASURES ADOPTED
USA	<p>NAME OF PRODUCT: 2011 Polaris Ranger RZR XP 900 recreational off-highway vehicles</p> <p>UNITS: About 4,500</p> <p>DESCRIPTION This recall involves 2011 model Polaris Ranger RZR XP 900 recreational off-highway vehicles. The machines are either white or red and have a "RZR XP" decal on the right and left rear side panels. The right and left of the hood have "Dual Overhead Cam" decals. There are also "900 EFI" decals on the front right and left of the machine.</p> <p>IMPORTER Unknown</p> <p>MANUFACTURED IN: United States</p>

<p>HAZARD: The firewall behind the driver and passenger seats can overheat and melt, posing a burn hazard to consumers.</p> <p>INCIDENTS/INJURIES The firm has received one report of an incident involving a consumer who received burn injuries to a finger.</p>	<p>Consumers should immediately stop using the vehicles and contact Polaris to schedule a free repair. Polaris is contacting its known customers directly.</p>
