PRODUCT **RECALLS**

THE SGS PUBLICATION GATHERING CONSUMER PRODUCT RECALLS
IN THE EU, IN THE USA AND IN AUSTRALIA

16 – 31 JANUARY 2012

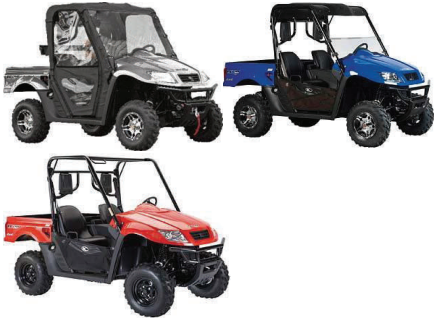
NOTIFYING COUNTRY	PRODUCT	DANGER	MEASURES ADOPTED									
USA	<p>NAME OF PRODUCT: Utility Vehicle UNITS: About 1,876 IMPORTER: KYMCO USA, of Spartanburg, S.C. DESCRIPTION: The recall involves 2009 through 2012 KYMCO utility task vehicles (UTVs). The vehicles are gasoline-powered, off-road vehicles with two side-by-side seats, a cargo bed and a steering wheel. The vehicles come in red, blue, black, gray, orange, silver and green and have the model and brand name "KYMCO" on both sides of the rear fender area and the front of the hood. The following UTVs are being recalled:</p>

MODELS	MODEL YEAR	VEHICLE IDENTIFICATION NUMBER (VIN) RANGE	UXV 500 UXV 500 LE UXV 500 SE	2009 2010 2011 2012	RFBUS37A 09B100101 through 9CB490364	UXV 500i UXV 500i LE UXV 500i SE	2012	RFBUS33A 4CB100101 through 8CB230205	<p>HAZARD: An exposed portion of the exhaust system can allow debris such as leaves, brush or other flammable materials to enter the opening and ignite, posing a fire hazard.</p> <p>INCIDENTS/INJURIES: KYMCO USA has received three reports of vehicles catching on fire and being damaged. No reports of injuries have been received.</p>	Voluntary recall.
MODELS	MODEL YEAR	VEHICLE IDENTIFICATION NUMBER (VIN) RANGE										
UXV 500 UXV 500 LE UXV 500 SE	2009 2010 2011 2012	RFBUS37A 09B100101 through 9CB490364										
UXV 500i UXV 500i LE UXV 500i SE	2012	RFBUS33A 4CB100101 through 8CB230205

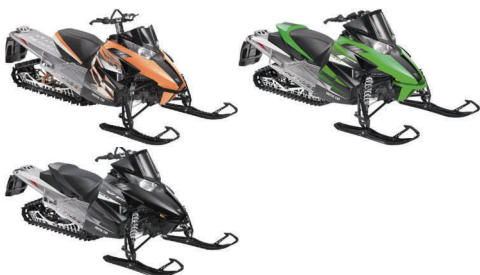
MODEL	MODEL NAME/NUMBER	F	F800 LXR, F1100 LXR, F800 Sno Pro, F1100 Turbos, F1100 Sno Pro/Limited/50th	XF	XF800 LXR, XF1100 LXR, XF800 Sno Pro High Country, XF1100 Turbos, XF100 Limited/50th	M	M800, M1100, M800 Sno Pro, M1100 Sno Pro/Limited/50th, M800 HCR, M1100 Turbos	<p>HAZARD: The lower steering tie-rod attachment can loosen and cause loss of steering control, posing a crash hazard.</p> <p>INCIDENTS/INJURIES: Arctic Cat has received four reports of incidents, including one complete loss of steering control. No injuries have been reported.</p>	<p>Voluntary recall.</p>
MODEL	MODEL NAME/NUMBER										
F	F800 LXR, F1100 LXR, F800 Sno Pro, F1100 Turbos, F1100 Sno Pro/Limited/50th										
XF	XF800 LXR, XF1100 LXR, XF800 Sno Pro High Country, XF1100 Turbos, XF100 Limited/50th										
M	M800, M1100, M800 Sno Pro, M1100 Sno Pro/Limited/50th, M800 HCR, M1100 Turbos
