PRODUCT RECALLS

THE SGS PUBLICATION GATHERING CONSUMER PRODUCT RECALLS
IN THE EU, IN THE USA AND IN AUSTRALIA

16– 31 OCTOBER 2011

AUTOMOTIVE

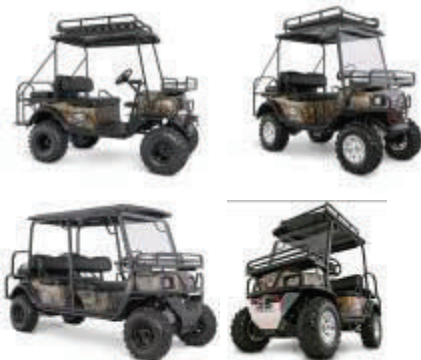
AUTO: MOTOR VEHICLE EQUIPMENT			
NOTIFYING COUNTRY	PRODUCT	DA NGER	MEASURES ADOPTED
USA	<p>NAME OF PRODUCT</p> <p>Bad Boy Buggies off-road utility vehicles</p> <p>UNITS</p> <p>About 3,200 (Bad Boy Classic buggies were previously recalled in October 2009 and in December 2010)</p> <p>MANUFACTURER</p> <p>BB Buggies Inc., of Augusta, Ga. and Bad Boy Enterprises LLC, of Natchez, Miss.</p> <p>DESCRIPTION</p> <p>This recall involves Bad Boy LT, Classic, XT, XTO and XT Safari model electric off-road utility vehicles. The utility vehicles have four wheels, bench seats for the operator and passengers and were sold in camouflage patterns, hunter green, red and black. "Bad Boy" is printed on the side or front of the vehicles.</p> <p>MANUFACTURED IN: United States</p>

<p>HAZARD</p> <p>The steering assembly arm can break and cause the driver to lose control, posing a crash hazard.</p> <p>INCIDENTS/INJURIES</p> <p>The firm has received 15 reports of the steering assembly arm breaking. No injuries have been reported.</p>	<p>Voluntary recall.</p>
