# PRODUCT **RECALLS**

THE SGS PUBLICATION GATHERING CONSUMER PRODUCT RECALLS  
IN THE EU, IN THE USA AND IN AUSTRALIA

1 – 15 MAY 2010

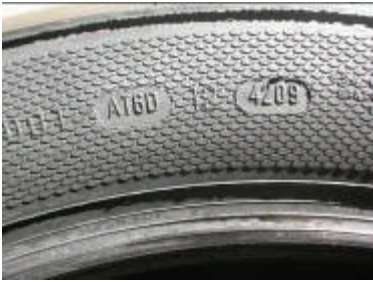
AUSTRALIA	<p>Pro Accessories Australia—Avon Cobra AV72 240/50 R16</p> <p><b>PRODUCT DESCRIPTION</b> Rear motorcycle tyre</p> <p><b>IDENTIFYING FEATURES</b> Batches 4109, 4209 and 4409</p> <p><b>SUPPLIER</b> Pro Accessories Australia Supplier's web site <a href="http://www.proaccessories.com.au">http://www.proaccessories.com.au</a></p>

<p><b>HAZARDS</b> Tyre puncture and the possibility of serious injury to the rider.</p> <p><b>DEFECTS</b> Manufacturing irregularity which could result in separation of components and tyre puncture.</p>	<p><b>CONSUMERS ACTION</b> Immediately contact the dealer where they purchased the tyre and get them to replace the tyre as soon as possible. Owners of the affected tyres should ring Pro Accessories Australia on 1800 761 300 between the hours of 9am-5pm Mon-Fri to organise a free replacement.</p>

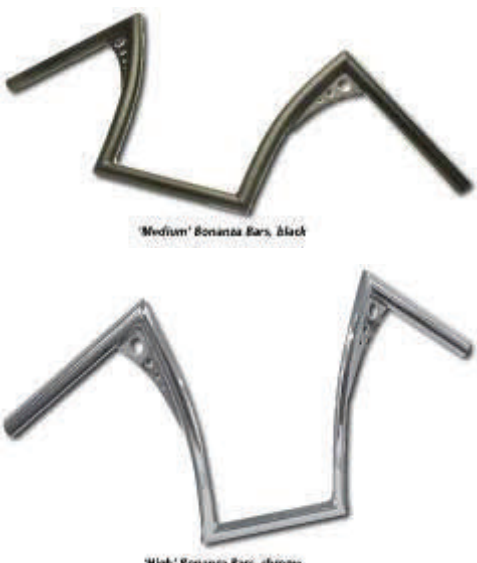
EU/GERMANY	<p><b>CATEGORY:</b> Motor vehicles</p> <p><b>PRODUCT:</b> Motorcycle handlebars - Bonanza</p> <p><b>BRAND:</b> Santee Designer Series</p> <p><b>TYPE/NUMBER OF MODEL:</b> Part numbers: CCE 696732, CCE 696702, CCE 696733, CCE 696703, CCE 696735, CCE 696705, CCE 696736, CCE 696706.</p> <p><b>DESCRIPTION:</b> Aftermarket handlebars for motorcycles. "High" and "Medium". Both models in black or chrome-plated.</p> <p><b>COUNTRY OF ORIGIN:</b> Taiwan</p>

<p><b>INJURIES</b></p> <p>The product poses a risk of injuries because the welding seams may develop cracks and, in extreme cases, break altogether.</p>	<p>Voluntary recall from consumers by the importer.</p>
