# PRODUCT **RECALLS**

THE SGS PUBLICATION GATHERING CONSUMER PRODUCT RECALLS  
IN THE EU, IN THE USA AND IN AUSTRALIA

1 – 15 JUNE 2010

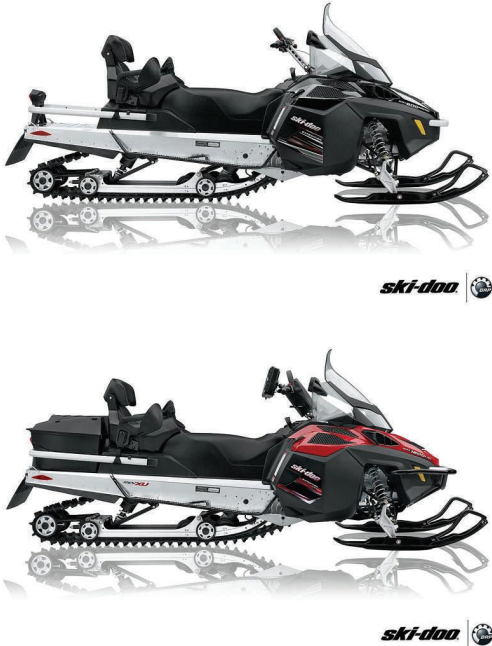
</div>	<p><b>HAZARD:</b> Friction between the fuel hose and the electronic control unit can cause the fuel hose to wear and leak fuel, posing a fire hazard.</p> <p><b>INCIDENTS/INJURIES:</b> BRP has received six reports of fuel leaks, three of which resulted in vehicle fires. One of the incidents involved a rider suffering superficial burns.</p>	Voluntary recall
