PRODUCT **RECALLS**

THE SGS PUBLICATION GATHERING CONSUMER PRODUCT RECALLS
IN THE EU, IN THE USA AND IN AUSTRALIA

16 – 31 JANUARY 2012

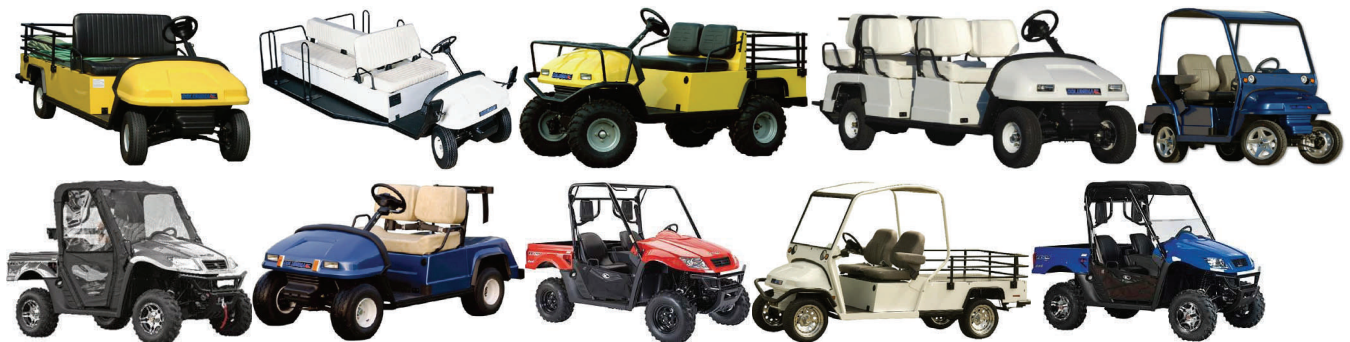
NOTIFYING COUNTRY	PRODUCT	DANGER	MEASURES ADOPTED									
USA	<p>NAME OF PRODUCT: Utility Vehicle UNITS: About 1,876 IMPORTER: KYMCO USA, of Spartanburg, S.C. DESCRIPTION: The recall involves 2009 through 2012 KYMCO utility task vehicles (UTVs). The vehicles are gasoline-powered, off-road vehicles with two side-by-side seats, a cargo bed and a steering wheel. The vehicles come in red, blue, black, gray, orange, silver and green and have the model and brand name "KYMCO" on both sides of the rear fender area and the front of the hood. The following UTVs are being recalled:</p>
